ASSESSMENT SUMMARY SHEET FOR UKAB MEETING ON 20th MARCH 2013

AIRPROX REPORT No 2012131

Date/Time: 23 Aug 2012 1354Z

Position: 5047N 00016W
(Shoreham NDB Hold)

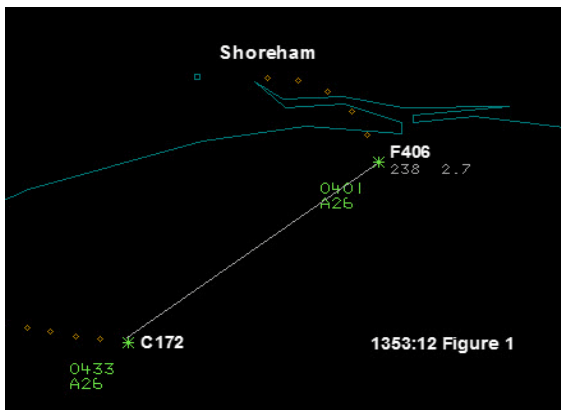
At 1353:12 the F406 pilot had crossed over the SHM NDB and was in a R turn, tracking S at 2600ft. The C172 was 2.5nm SSW of Shoreham tracking E, also at 2600ft (see Figure 1 below).

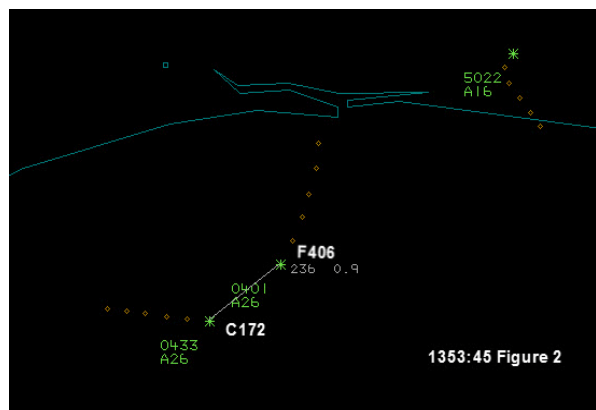
At 1353:45 the F406 was tracking SSW, joining for the NDB procedure while the C172 was tracking E, 0.9nm WSW of the F406 (see Figure 2 below).

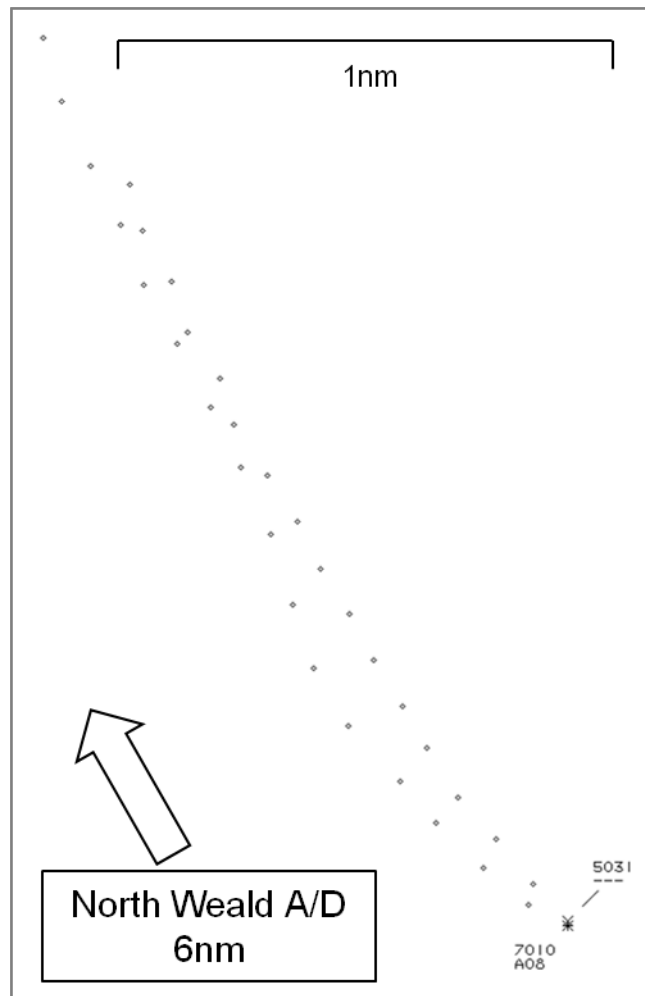
[UKAB Note(1): The Stansted 10cm radar recording at 1402:14 is reproduced below:

The radar contact trail is at 4sec spacing]

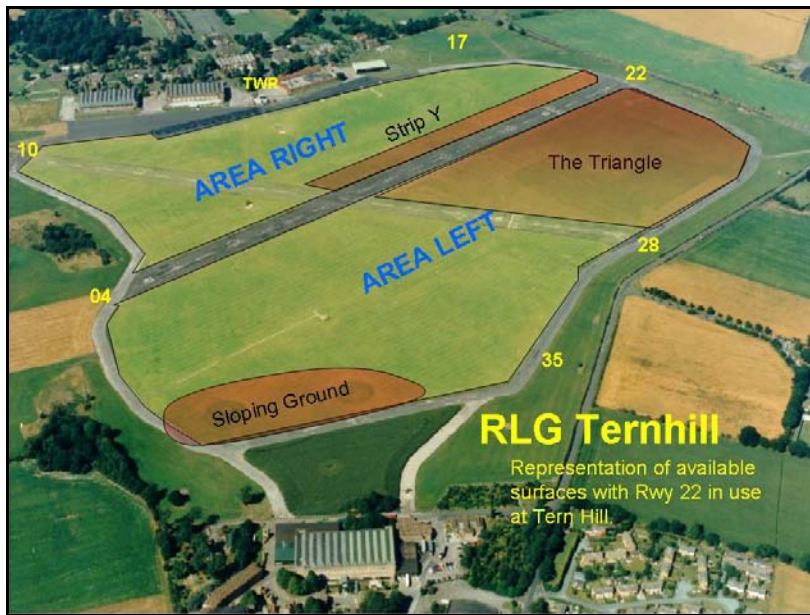
Figure 1: Operating Surfaces at Ternhill.

At the time of the incident, RW22 was the designated duty RW at Ternhill; however, given its use as a RW RLG, Ternhill has a number of operating surfaces available as depicted at Figure 1.

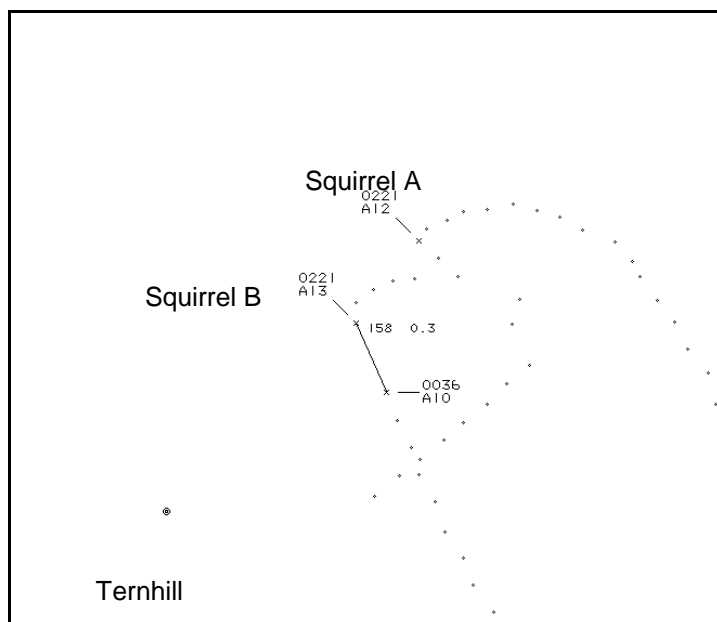
Figure 3: Incident Geometry at 1007:11

The pilot of Squirrel (A) stated in their DASOR that, as they highlighted their concerns over the transiting R44, at approximately 1007:10, they visually acquired the R44 in their 'approximately 11 o'clock position, at approx 100m if not closer'. Comparison of the radar, RT transcript and DASOR shows that lateral separation between the R44 and Squirrel (A) at this point was 0.7nm. At 1007:11, immediately following the Squirrel (A) pilot's last transmission, Squirrel (C) flight (SW of Ternhill) reported, *“finals 1-80 engine off for the triangle”*; Figure 3 depicts the building incident geometry at this point. Squirrel (A) pilot immediately transmitted to Squirrel (C) flight at 1007:14, *“(Squirrel C c/s) standby go-around”* which was not acknowledged by either the ADC or Squirrel (C). The Unit's investigation determined that the pilot of Squirrel (A) erroneously believed that Squirrel (C) was Squirrel (B) ahead of them. At 1007:19, Squirrel (B) pilot reported, *“...finals, engine off for the go-around”*; Figure 4 depicts the incident geometry at that point. Due to further exchanges of RT, Squirrel (B) pilot's finals call was not acknowledged by the ADC.

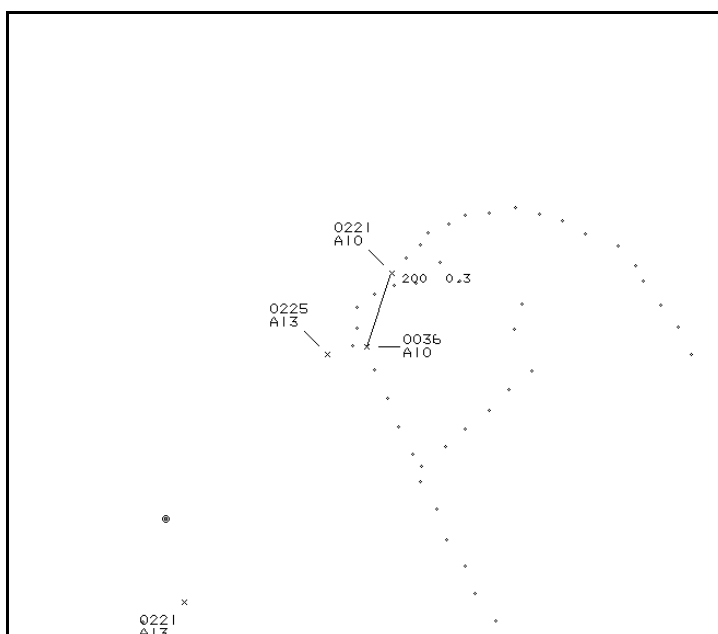
Figure 4: Incident Geometry at 1007:19

The CPA with Squirrel (B) occurs between radar sweeps at 1007:17 as the R44 crosses 0.2nm behind the Squirrel indicating 300ft below; the crew of Squirrel (B) did not visually acquire the R44. As can be seen in Figure 4, the PSR and SSR return of Squirrel (B) was subject to significant track jitter and code garbling following the Airprox. The CPA with Squirrel (A) occurs at 1007:23 as the R44 passes 0.2nm ahead of the Squirrel at the same indicated height. The R44 pilot stated in their report that Squirrel (A) was 'slightly lower' than them and 'seemed slow'; they did not 'think a collision was likely but on passing did think it (Squirrel A) was closer than expected'.

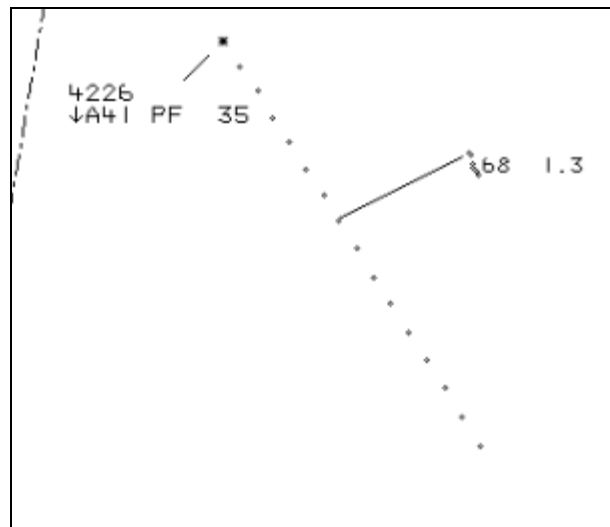
Figure 1: 1255:20 UTC (Prestwick MRT)

Figure 1 below shows the Prestwick (ACC) Multi Tracking Radar picture at 1255:20. The A320 is transponding Mode A code 4226. The distance between each marker in the replay trail history is equivalent to 4sec. The Figure shows no other track histories within the immediate vicinity of the A320 at this time. There is an unidentified track history 1.3nm E of the A320's position 28 seconds earlier, but no surveillance data to suggest a detectable object passing underneath the A320.

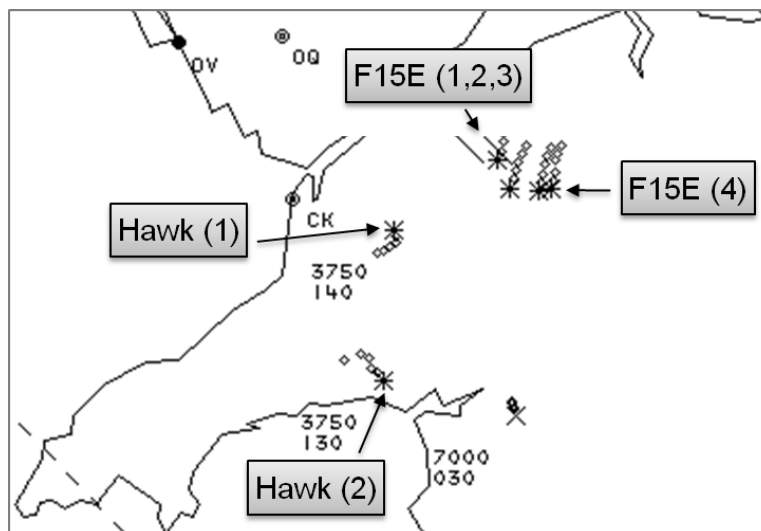
Figure 3: Incident Geometry at 1202:21.

The incident sequence commenced at 1202:21 as Hawk (2) free-called W Tac on the W ICF using his individual C/S. At this point, Hawk (2) was 22.6nm SE of Valley, tracking SE'ly, indicating FL130. Hawk (1) was 8.6nm N of Hawk (2), tracking NW'ly, indicating FL140. The incident F15E formation were operating between 7.1nm and 9.2nm NE and ENE of Hawk (1), tracking SSW'ly, indicating between FL206 to FL212. The unrelated F15E formation was 69.3nm S of the incident F15E formation, tracking E'ly, indicating between FL259 and FL287 within the NWM TA. Figure 3 depicts the incident geometry at this point.

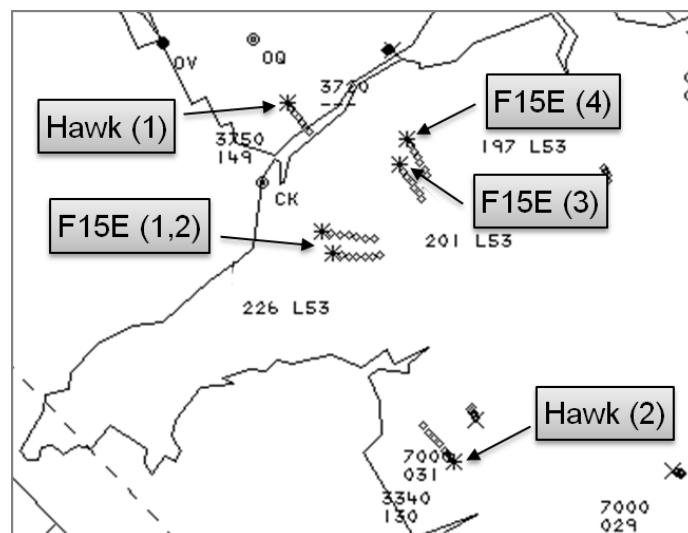
Figure 4: Incident Geometry at 1203:43.

Immediately after Hawk (2) pilot’s acknowledgement of the squawk for Hawk (1), W Tac advised, at 1203:18, “[Hawk (1) C/S] identified, Flight Level 1-3-0, Traffic Service.” However, whilst W Tac had utilised Hawk (1)’s C/S, he had identified Hawk (2) as it was Hawk (2) that was maintaining FL130 and Hawk (1) had not yet begun to squawk the assigned SSR3A code. Hawk (2) replied at 1203:24, “sorry, stepped on, say again for [Hawk formation C/S]” and again at 1203:31, “London [Hawk formation C/S] say again.” W Tac replied at 1203:33, “[Hawk formation C/S] identified Traffic Service, confirm Flight Level 1-3-0?” Although live-mic recording was not available, given W Tac’s transmissions at 1203:18 and 1203:33, it is likely that the delay in W Tac replying to Hawk (2) was that his instructor had prompted him to verify Hawk (2)’s level, rather than assume that the displayed SSR Mode C information was correct. Hawk (2) pilot confirmed that he was at FL130 and advised W Tac that the formation were, “looking to work in the block Flight Level 100, Flight Level 300.” W Tac then replied, using Hawk (1)’s C/S, instructing the [Hawk (2)] pilot to, “manoeuvre as required between FL100 and FL300, report 1 minute to completion. Be advised there’s 7 F-15s operating within the North Wales M-T-A.” This was acknowledged by Hawk (2) using the formation C/S. At this point Hawk (1) pilot had not commenced squawking the SSR3A code assigned to him and was 9.3nm WNW of F15E (4) and 25.7nm NNW of Hawk (2). Figure 4 depicts the incident geometry at this point.

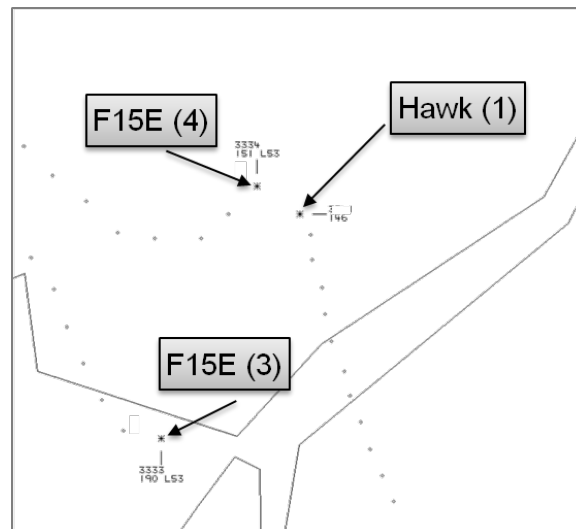
Figure 5: Incident Geometry at 1206:39 immediately prior to the CPA.

At 1206:16, transmitting on both the Hawk and F15E formation's frequencies, W Tac trainee attempted to provide TI to the N'ly F15E formation on Hawk (1); however, quoting the W Planner, the trainee 'stumbled' over his phraseology, prompting the instructor to step in. The instructor stated, "[F15E formation C/S] Hawk west...east 2 miles, manoeuvring, Flight Level 1-5-0, operating in the block Flight Level 300 Flight Level 100", which was acknowledged using the F15E formation C/S. However, based on the F15E formation's report, it was not the formation leader who acknowledged the TI, a point that will be examined later. At the time the W Tac trainee attempted to pass TI, F15E (3) and F15E (4) were 4.5nm and 4.8nm respectively NW of Hawk (1), tracking SE'ly, indicating FL180 and FL175 respectively. As the instructor passed TI to the F15E formation, at 1206:28, F15E (4) turned left approximately 30° introducing the conflict with Hawk (1), 2.3nm ESE of him. At 1206:36, F15E (4) turned left approximately a further 45° and commenced a rapid descent, further reducing the separation on Hawk (1). This detail can be seen in Figure 5. Extrapolation of the radar data demonstrated that approximately 2.1nm lateral separation would have existed between Hawk (1) and F15E (4), prior to this manoeuvre. Immediately after the F15E formation's acknowledgement of the TI, the W Tac instructor replied to an unrelated free-calling ac on the SW ICF, instructing them to, "standby". The CPA between Hawk (1) and F15E (4) occurred between radar sweeps at approximately 1206:42 as F15E (4) crossed 0.2nm L to R through Hawk (1)'s 12 o'clock. Figure 5 depicts the incident geometry at 1206:39 at the radar sweep immediately prior to the CPA. In the radar sweep immediately after the CPA, at 1206:43, the F15E is shown having made a tight R turn through 45° towards Hawk (1), indicating FL153. Hawk (1) was indicating FL135, after his 'avoiding action...descending to the left'; Figure 6 shows this detail with the flight path of F15E (4) highlighted in red and that of Hawk (1) highlighted in blue.

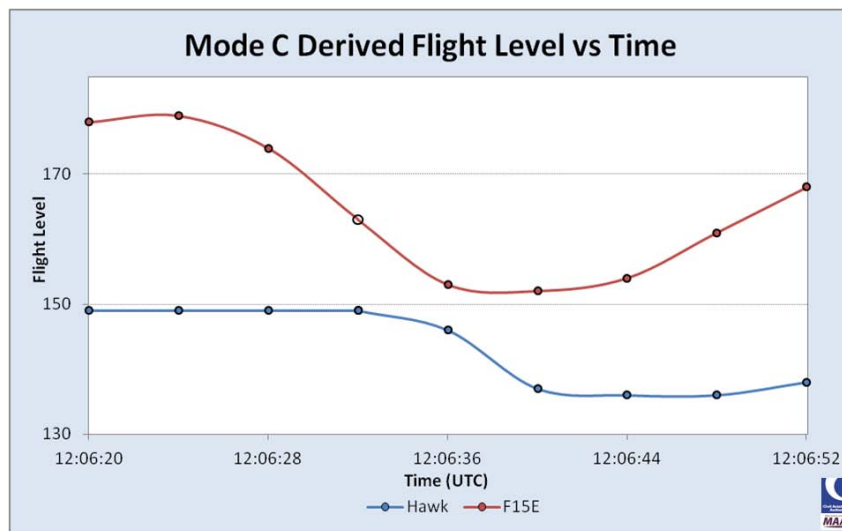
[UKAB Note(2): The vertical profile of the encounter, derived from Mode C data, is shown below:

Note that the F15E Flight Level is interpolated between 12:06:28 and 12:06:36 as its RoD exceeded the surveillance system parameters for processing height readout.]
